# TUGAS AKHIR

MENENTUKAN PRIORITAS PENANGANAN JALAN  
DI KABUPATEN KARAWANG BERDASARKAN KLAS DAN  
KONDISI JALAN SERTA DANA YANG TERSEDIA

BIDANG STUDI PERHUBUNGAN  
JURUSAN TEKNIK SIPIL  
FAKULTAS TEKNIK SIPIL DAN PERENCANAAN  
INSTITUT TEKNOLOGI SEPULUH NOPEMBER  
SURABAYA  
1994

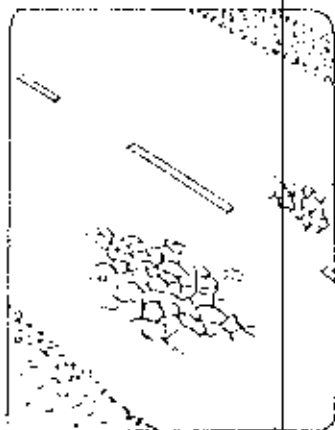
Retak kulit buaya  
(alligator cracks)

#### 1. Alligator cracks (Retak kulit buaya)

Adalah keretakan yang saling berhubungan membentuk kotak-kotak kecil yang mirip dengan kulit buaya. Alligator cracks dapat disebabkan oleh ketidakstabilan permukaan bawah akibat subgrade yang jenuh air, sehingga perkerasan mengalami lendutan yang berlebih. Hal demikian terjadi pada area yang tidak luas Tetapi apabila beban lalu

lintas yang lewat melebihi kapasitas perkerasan maka alligator crack akan terjadi pada keseluruhan permukaan jalan.

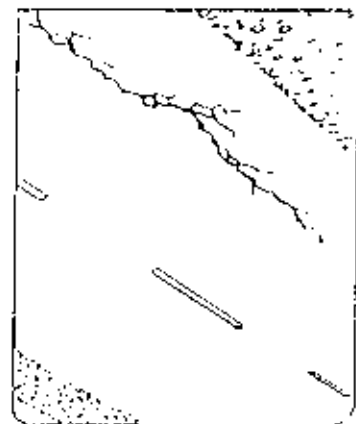
Retak pinggir  
(edge cracks)

2. Edge cracks (Retak tepi)

Berupa retak memanjang, dengan atau tanpa retak melintang kearah bahu jalan. Retak semacam ini umumnya paralel dengan tepi perkerasan, dan terletak sampai  $\pm$  30 cm dari tepi perkerasan. Umumnya edge crack disebabkan karena lemahnya daya dukung lateral dari bahu jalan. Retak ini dapat juga disebabkan karena penurunan atau penggemburan material dibawah tepi perkerasan. Akar-akar pohon di tepi jalan juga dapat menyebabkan keretakan tepi perkerasan.

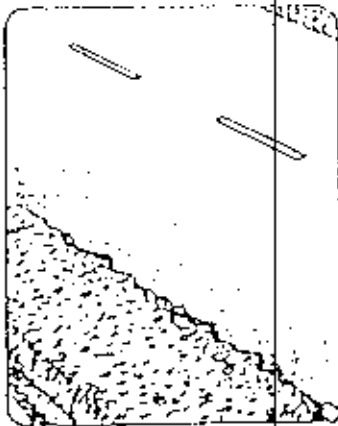
Retak pertemuan  
perkerasan dan  
bahu (edge joint  
cracks)

3. Edge joint crack (Retak sambungan tepi perkerasan)

Biasanya berupa retak yang cukup dalam. Retak ini memisahkan perkerasan dengan bahu jalan. Penyebabnya keadaan tanah dibawah bahu yang mengalami perubahan kadar air, yang disebabkan kondisi drainase yang buruk. Kondisi bahu yang lebih tinggi dari perkerasan utama atau penurunan tepi perkerasan menyebabkan air tidak dapat mengalir dan meresap lewat sambungan juga merupakan penyebab edge joint cracks.

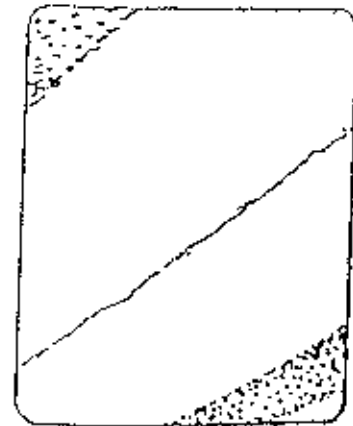
Retak sambungan ja-  
lan (lane joint cracks)

## 4. Lane joint cracks (Retak sambungan jalur)

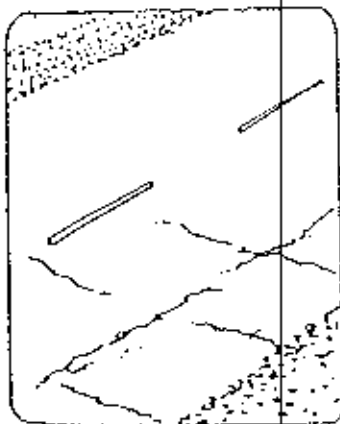
Retak refleksi  
(Reflection cracks)

## 5. Reflection cracks (Retak refleksi)

Merupakan keretakan pada asphalt overlay yang merefleksikan keretakan struktur perkerasan dibawahnya. Bentuk keretakan dapat berupa longitudinal, tranverse, diagonal atau berupa blok. Reflection crack sering terjadi pada perkerasan fleksibel dengan portland cement treated base. Reflection cracks dapat juga terjadi pada overlay perkerasan lama, dimana keretakan perkerasan lama tidak diperbaiki terlebih dahulu. Penyebab dari Reflection crack adalah pergeseran vertikal atau horizontal pada perkerasan dibawah overlay.

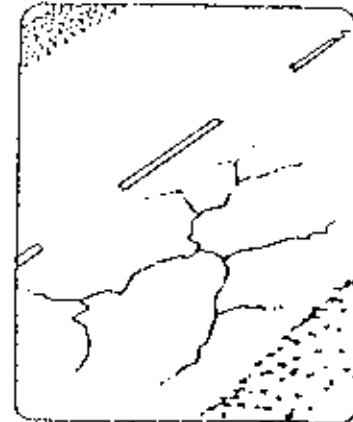
Retak susut  
(shrinkage cracks)

## 6. Shrinkage cracks (Retak susut)

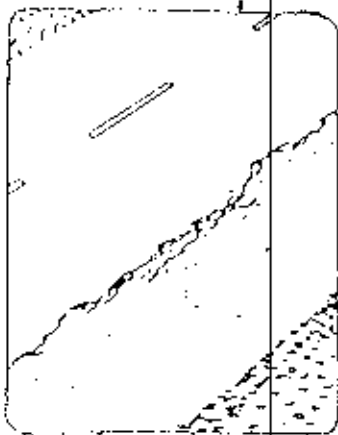
Retak sambungan pelebaran (widening cracks)

#### 8. Wedening cracks (Retak pada pelebaran)

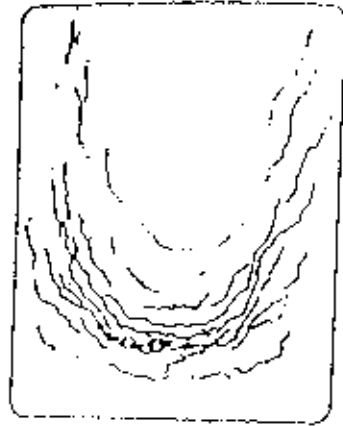
Retak selip (slippage cracks)

#### 7. Slippage cracks (Retak slip)

Adalah retak yang berbentuk bulan sabit searah dengan dorongan roda kendaraan pada permukaan perkerasan. Penyebabnya adalah tidak adanya rekatan yang baik antara lapisan permukaan dengan lapisandibawahnya. Hal ini dapat terjadi akibat adanya degu, minyak, karet, lumpur, air atau mineral non adhesive lainnya, antara kedua lapisan pada saat penghamparan. Tidak digunakan lapisan tack coat pada saat penghamparan juga mengakibatkan tidak adanya rekatan yang baik. Slippage crack dapat juga terjadi akibat campuran yang mengandung banyak pasir, kadang-kadang slippage crack terjadi karena ketidaksempurnaan pemadatan saat penghamparan.

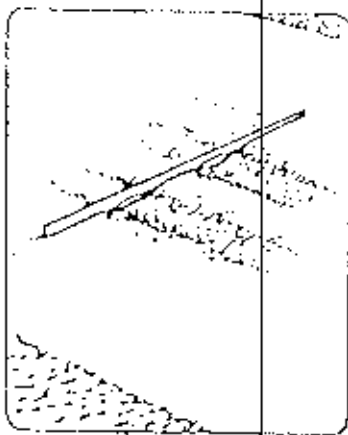
Alur (ruts)

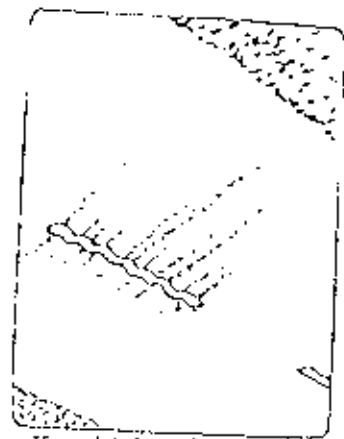
Keriting (corrugations)

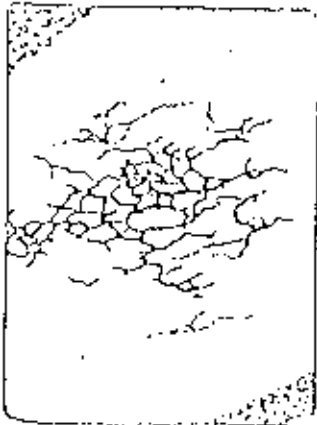
Jembul (Upheaval)

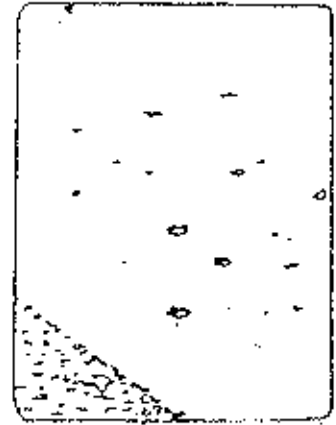
Pelepasan butir  
(ravelling)

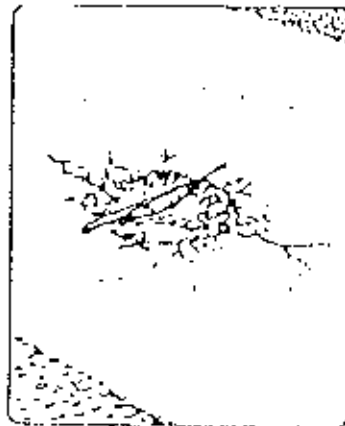
Amblas (depressions)

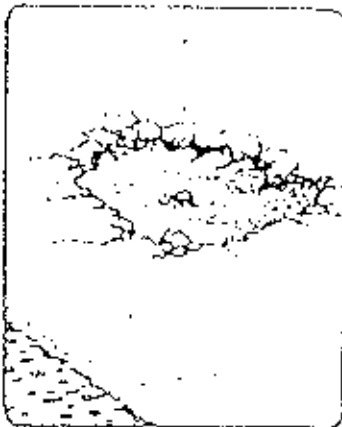
Lubang (pot hole)

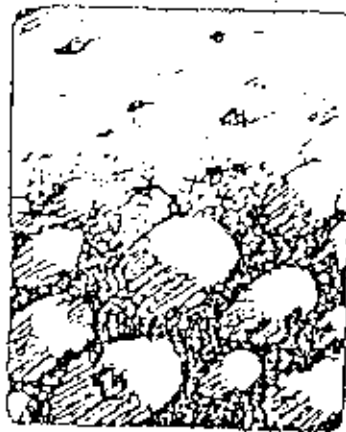
Pengausan (polished  
agregate) pada per-  
kerasan.

##### 2. Polished aggregate (Pengausan agregat)

Polished agregat adalah terjadinya pengausan pada partikel agregat permukaan perkerasan, agregat tersebut menjadi licin. Penyebabnya adalah adanya bergeseran dengan roda kendaraan. Jenis agregat mempengaruhi kecepatan pengausan. Agregat dari batu kapur lebih cepat aus dari pada agregat yang lain.

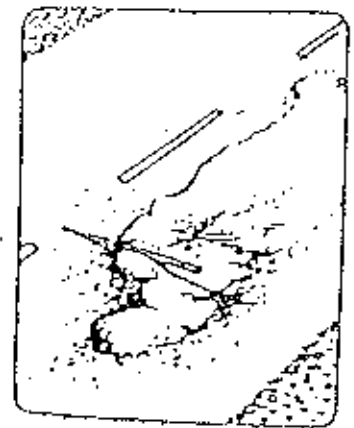
Kegomukan (bleeding)
